October 2, 2018

Cracked Glass Unit 36B Investigation

Millennium Tower San Francisco, CA

Job # 16-4094.01

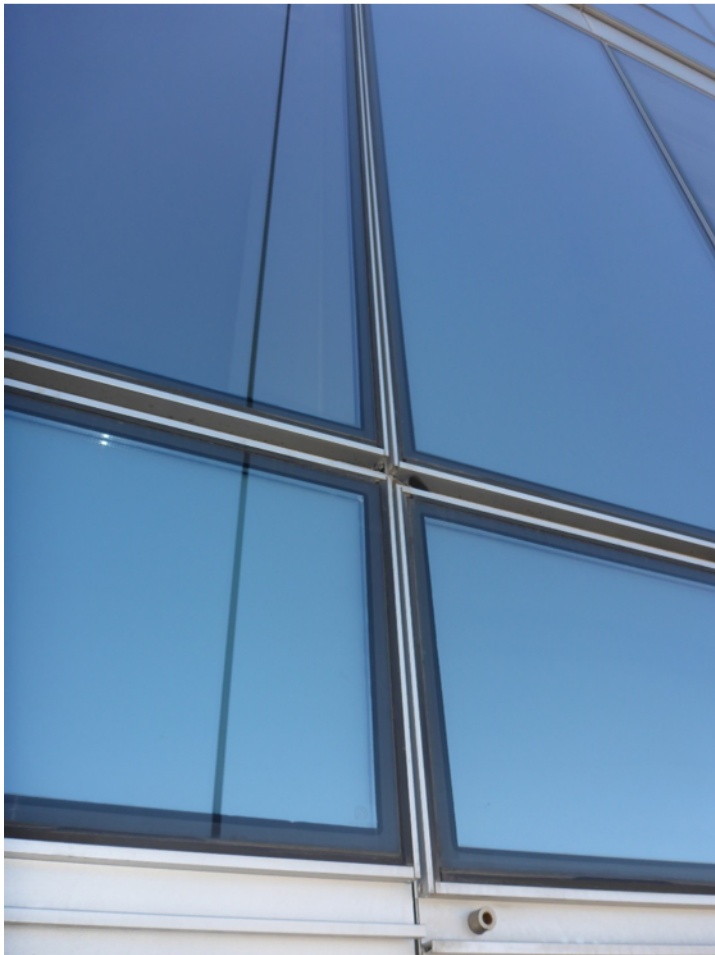
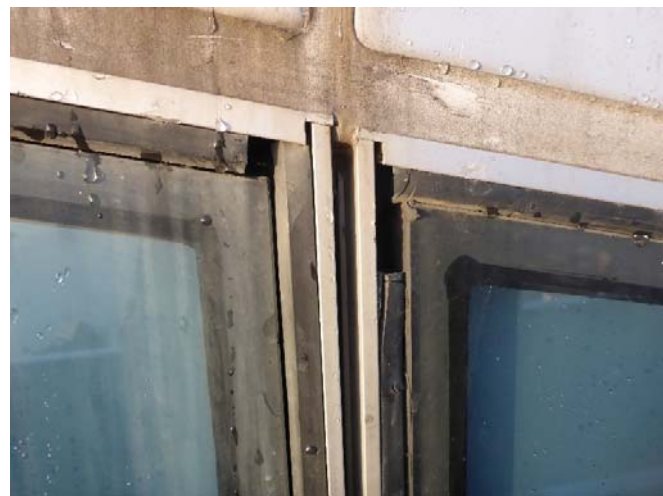
Based our drops as well as the drone survey, we observed that offset panels were isolated on a few stacks, on certain floors only.

TYPICAL PANEL OFFSETS OBSERVED

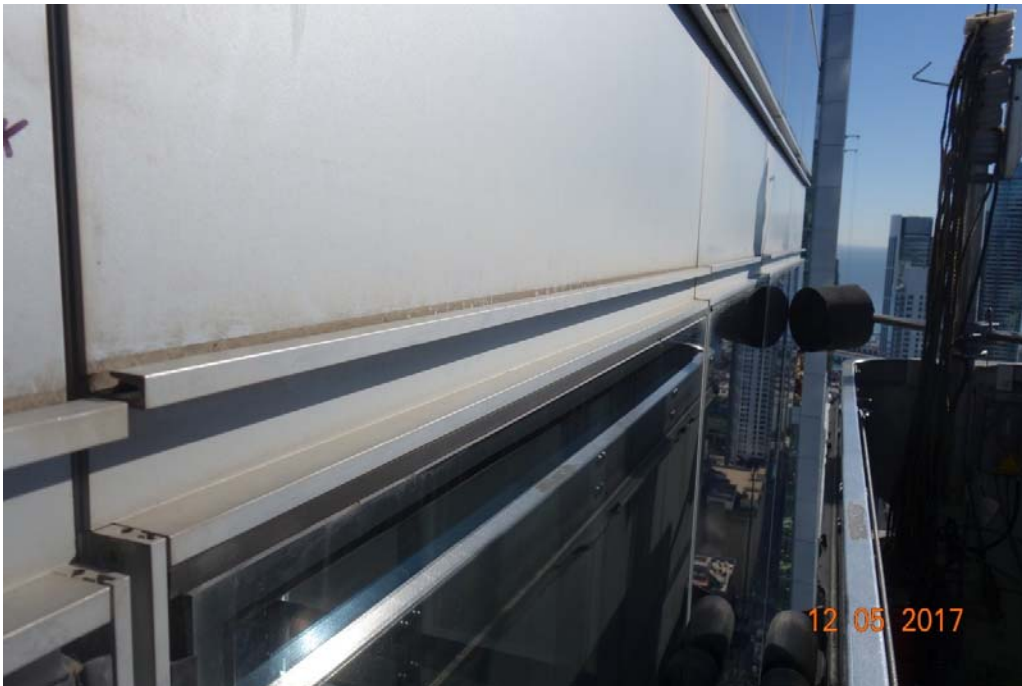
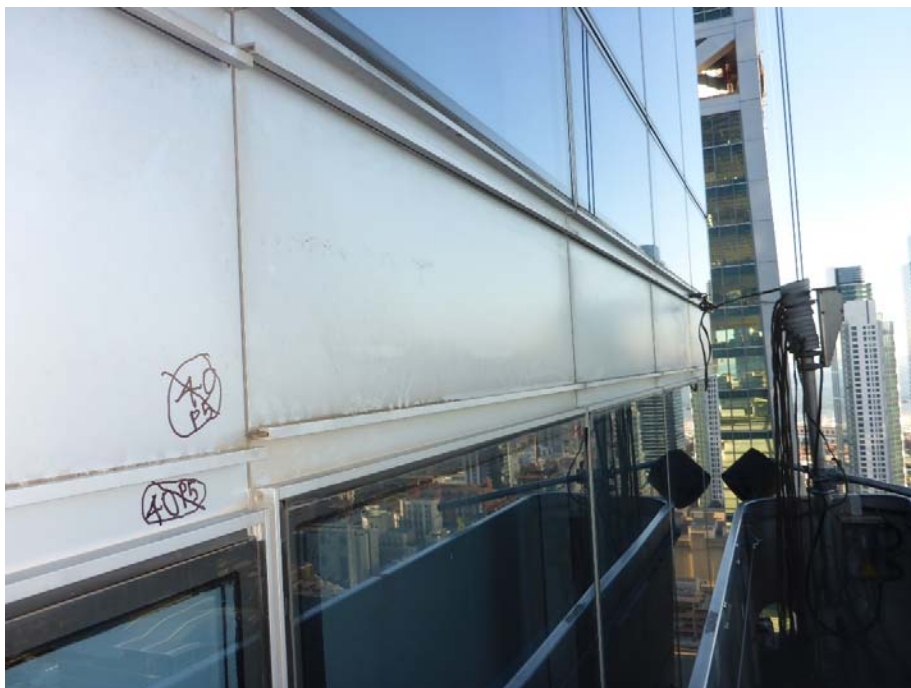
PRE-INVASIVE TESTING OBSERVATION OF SHIFTED PANELS

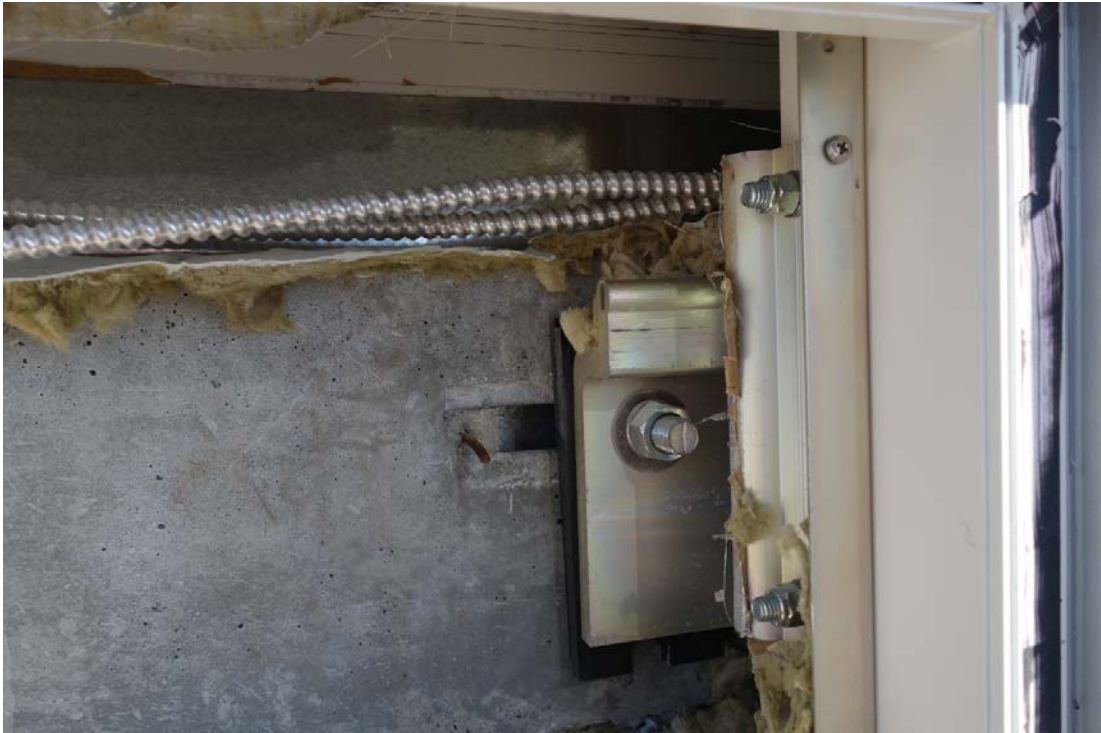
OBSERVATIONS OF THE CURTAIN WALL STRUCTURAL CONNECTIONS

Our observations of the five invasive testing locations all proved negative for any potential structural issues or the shifting of the curtain wall due to settlement.

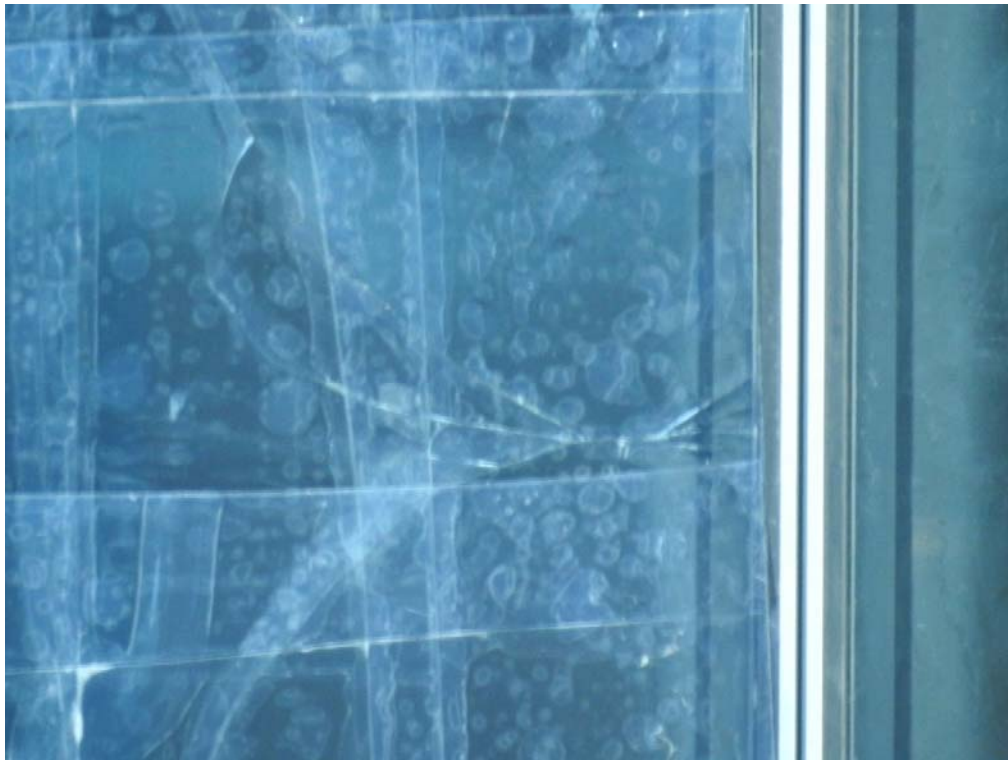
The first look ABBAE obtained from the exterior side of the glass was from a building across the street. ABBAE was able to gain access to the building on the 28th floor to photograph the cracked glass from a level vantage point. These photographs showed that the point where the cracks appear to initiate from is beyond the vertical mullion and is visible from the interior side of the building, but the edge of the glass where the break radiates to is not visible from the interior.

CLOSE-UP OF THE GLAZING CRACK AND SECURITY FILM INSTALLED

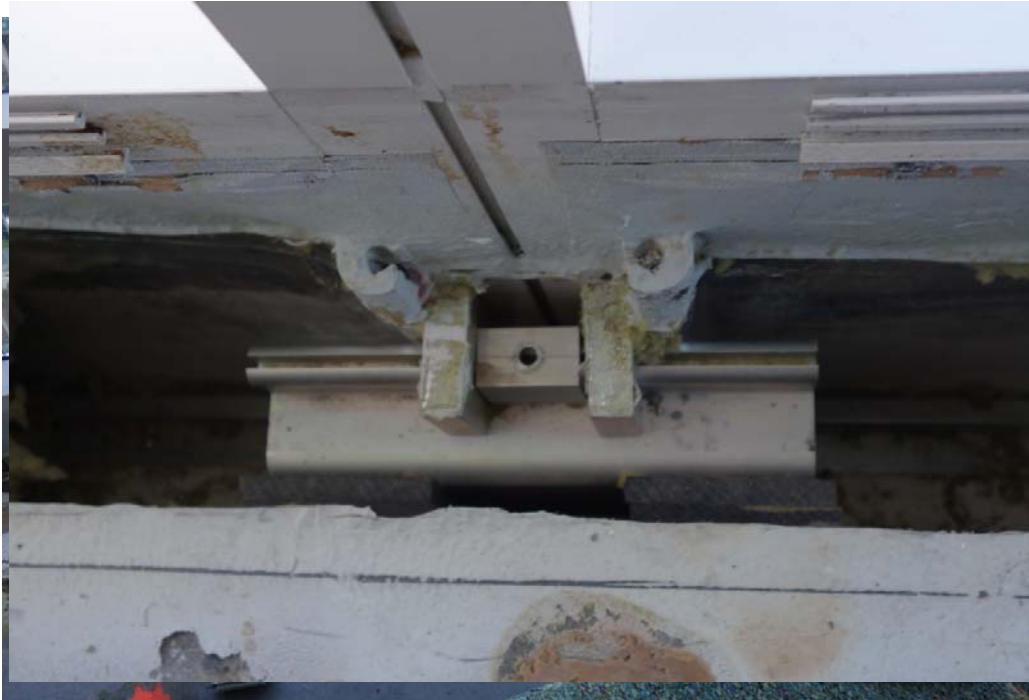
determined occurred during the initial installation. There was no deformation or signs of stress or recent movement in the structural connections.

CLOSE UP OF CURTAIN WALL CONNECTION AT SLAB EDGE

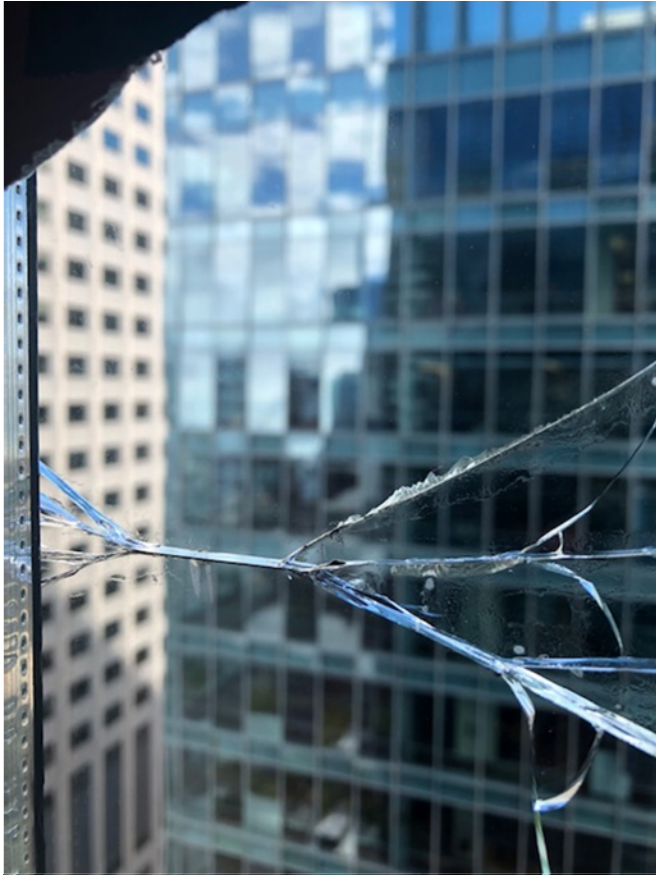
VIEW FROM THE INSIDE OF UNIT 36B

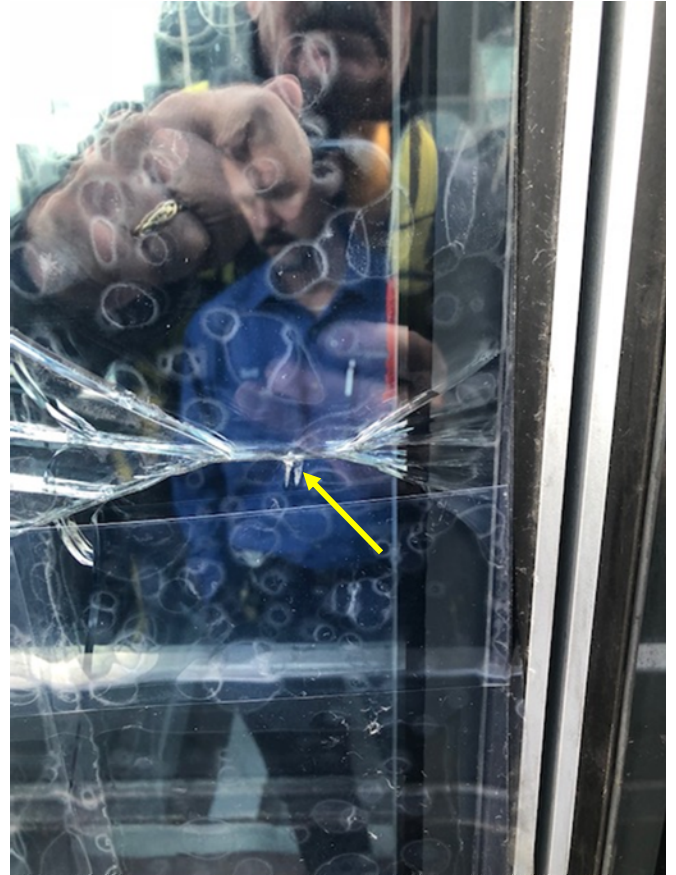
VIEW FROM EXTERIOR, AT SOURCE BREAK

ABBAE has looked at this damage and determined that the cracking is from a source break due to an exterior impact. The homeowner corroborates this damage observation with the report of a loud noise that awakened them, followed by continued noises as the glass breakage grew. Additionally, the slabs and ceilings in the unit do not show signs of movement capable of causing this type of damage. The curtainwall connections also do not show any abnormal movements that could in any way cause an IGU to break. The exterior observation shows there is uniform margins between the glass and curtainwall frame. From the exterior, there is no evidence that the glass made contact with any other curtainwall elements. Replacement glass has been ordered and we can further analyze the glass after removal. ABBAE does not recommend further action at this time for the glass in unit 36B.

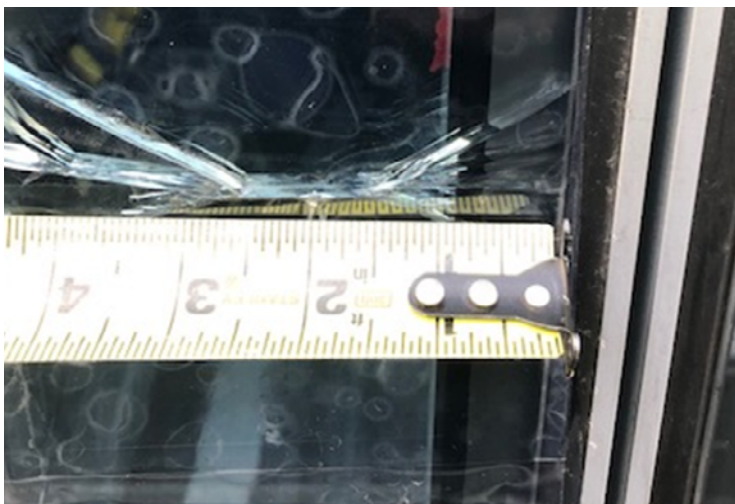
SOURCE BREAK IS 2" FROM EDGE OF GLASS

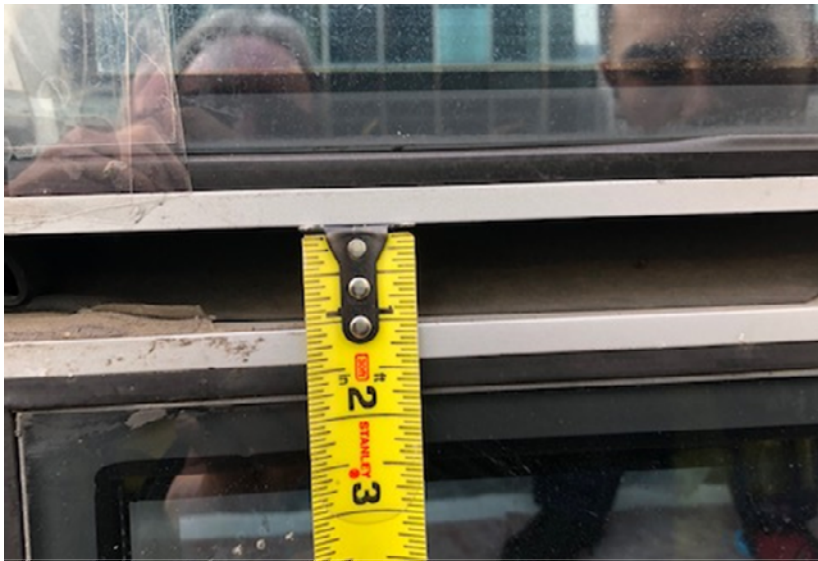
**PERIMETER GASKETS AROUND EDGES OF GLASS HAVE UNIFORM SPACING AND
HAVE NO EVIDENCE OF ANY CONTACT WITH ALUMINUM FRAME**
